Manhole Inspection Summary

Manhole # S63M__007MH

Location Address: **5501 O'Donnell St.**

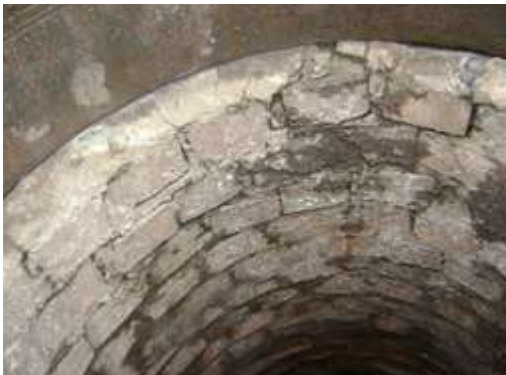
Defect 3

Infiltration: ☐ None ☒ **Joint** ☐ Cracks ☒ **Mortar** ☐ Roots ☐ Wall

Infiltration in chimney

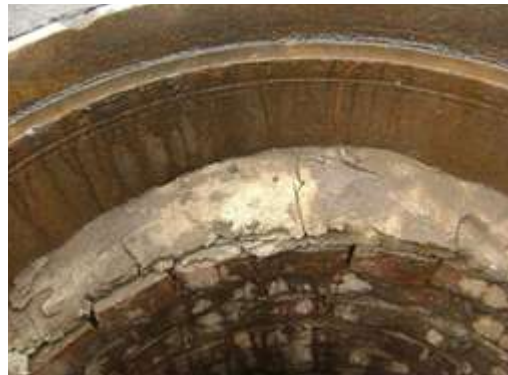
Defect 1

Offset: **2** (in.)

frame offset

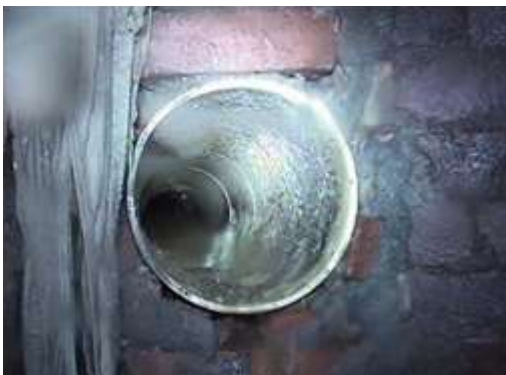
Defect 4

broken pipe seal 5:00-7:00 incoming 3 o'clock

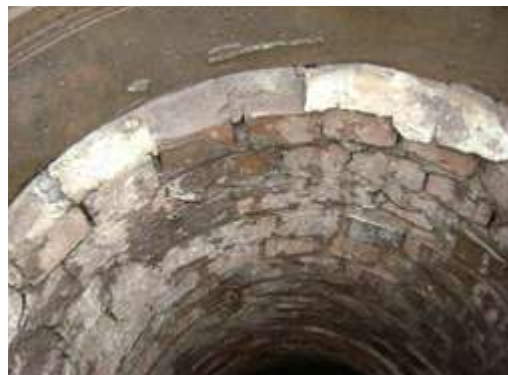
Defect 2

Condition: ☐ Sound ☐ Cracked ☐ Root Intrusion ☒ **Loose Brick** ☐ Deteriorated

Cracked mortar and loose bricks

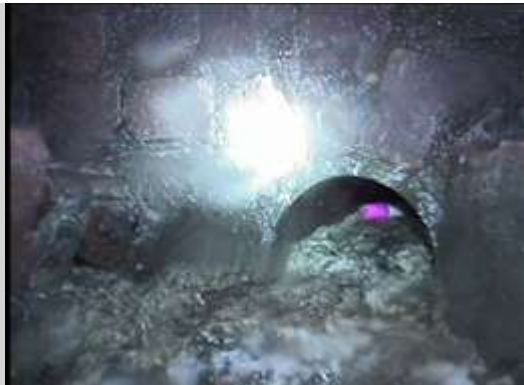
9 O'Clock Inflow

Deposits: ☐ None ☐ Mud ☐ Sludge ☒ **Debris** ☐ Grease

Silt Depth: **4** (in.) Deposits Extent: **Heavy**
